A systemic overview of the central venous catheter positioning in chest radiographs of ICU patients

Siddharthkumar B Parmar¹, Dinesh Venkatesan^{2*}, Rahul C Manek², Shweta Girishkumar Shah³

¹Assistant Professor, ²Second Year Resident Doctor, ³First Year Resident Doctor, Department of Anaesthesiology, B J Medical College, Ahmedabad. Gujarat, INDIA.

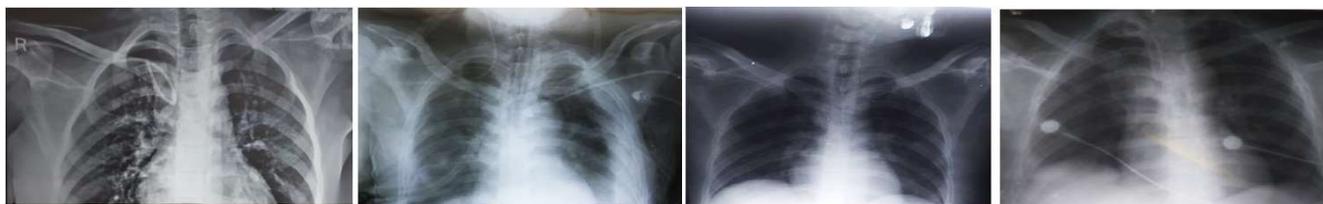
Image 1: improper course of CVC – coiling; **Image 2:** malposition of CVC into Ipsilateral Internal jugular vein 1; **Image 3:** malposition of CVC into Ipsilateral Internal jugular vein 2; **Image 4:** More length of CVC into right atrium

Total 59 (84.29%) CVC were placed correctly having proper course, adequate length of insertion with vertical tip of CVC and no any malposition or lung complications. Total 11(15.71%) CVC were wrongly placed having either improper course, length, tip, malposition or lung complications. In them 6(8.57%) and 2(2.86%) are having either more or less length of CVC insertion respectively. 5 (7.14%) CVC were having angled tip of CVC. 2 (2.86%) were having malposition CVC. Both malposition were into ipsilateral internal jugular vein only. There were no any lung complications seen in our study.

In present study, 5 (7.14%) CVC were having angled tip of CVC and 2 (2.86%) were having malposition CVC. Both malposition were into ipsilateral internal jugular vein only. There were no any lung complications seen in our study. In contrast to our results, the study²³ comparing right vs. left subclavian catheterizations in 193 patients undergoing coronary artery bypass graft surgery found malposition of the catheter tip on the right side (9.6%) was significantly more than the left side (0%). In ten patients, catheter tip was located in the ipsilateral internal jugular vein, and in one, in the contralateral subclavian vein. Pneumothorax occurred in 5 patients (4.3%) with right side catheterization only. We used subclavian route for central venous catheter as it is considered to be preferred site to minimize infection risk rather than a jugular or a femoral site.^{24,25,26,27} Right side was chosen as anatomy of vein and design of catheter facilitate proper insertion²⁴. However, left sided subclavian route will definitely increase the malposition and complications²⁴.
